# Home Report

70 Relugas Road  
Edinburgh EH9 2LZ

# Single Survey

| <b>Description</b> | The property comprises a purpose built upper flat within a two storey block. |

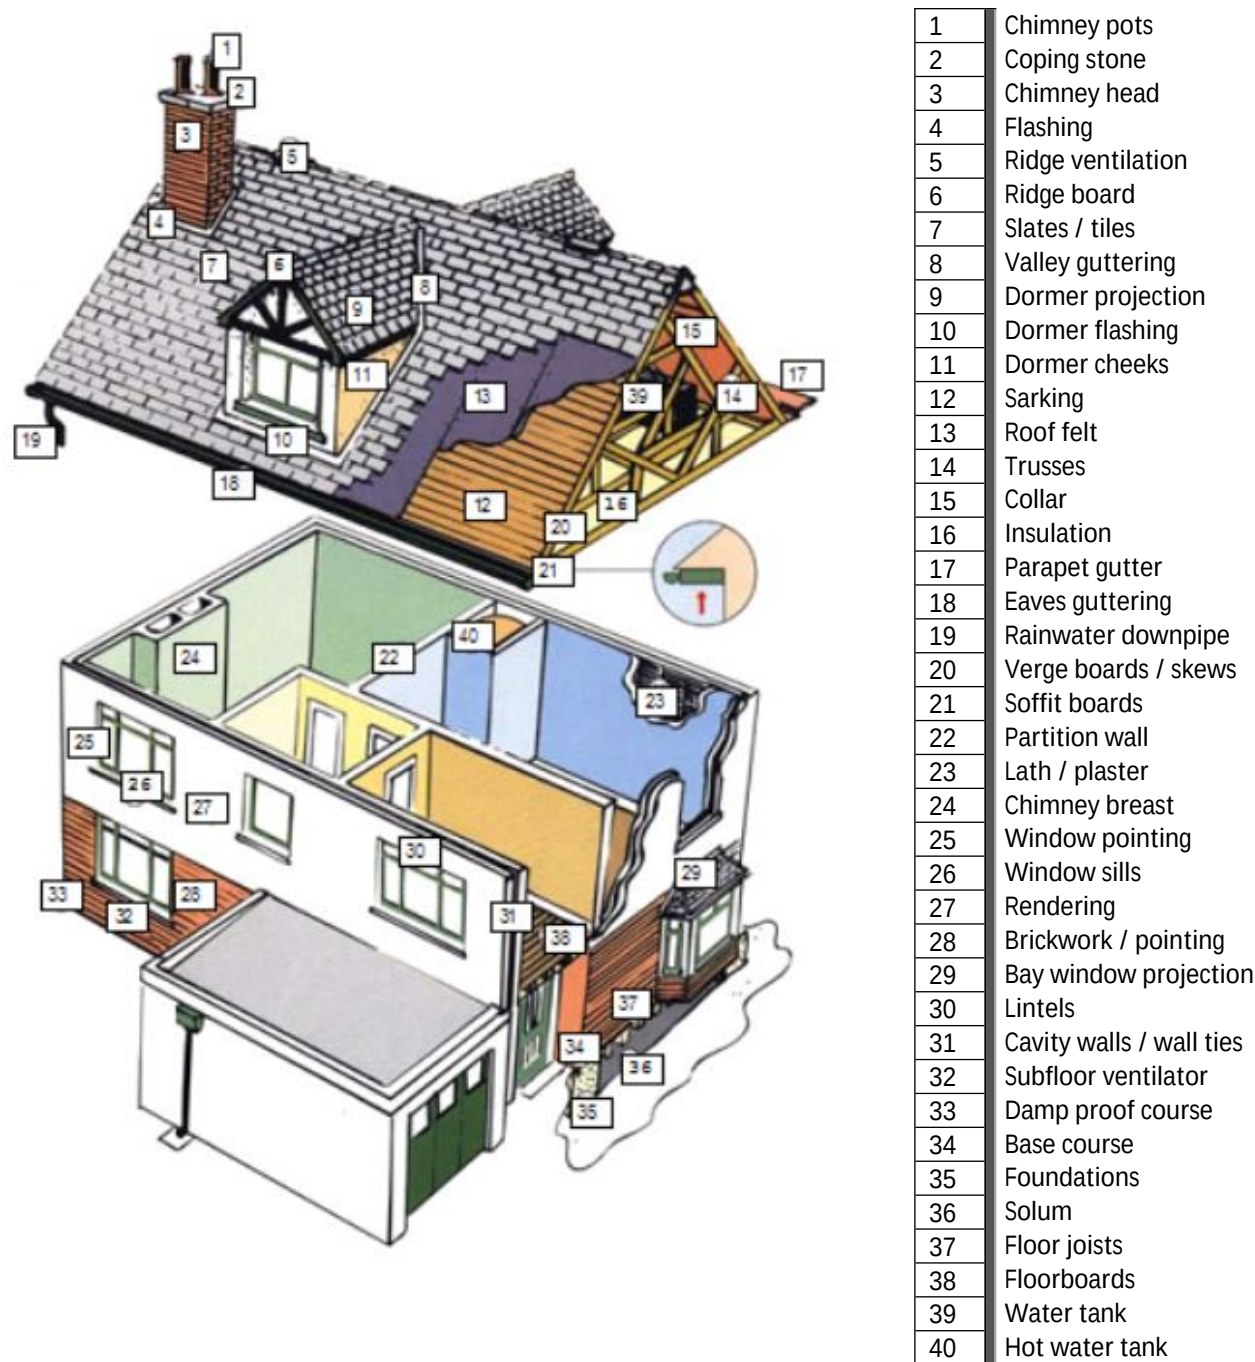
# Sectional diagram showing elements of a typical house

Reference may be made in this report to some or all of the above component parts of the property. This diagram may assist you in locating and understanding these items.
