Home Report

8 Malta Terrace
Edinburgh EH4 1HR

Single Survey

Property Address	8 Malta Terrace Edinburgh EH4 1HR
Customer	Lady Margaret Elizabeth Scott
Prepared by	Graham + Sibbald Property Consultants Limited
Date of Inspection	25/06/2026

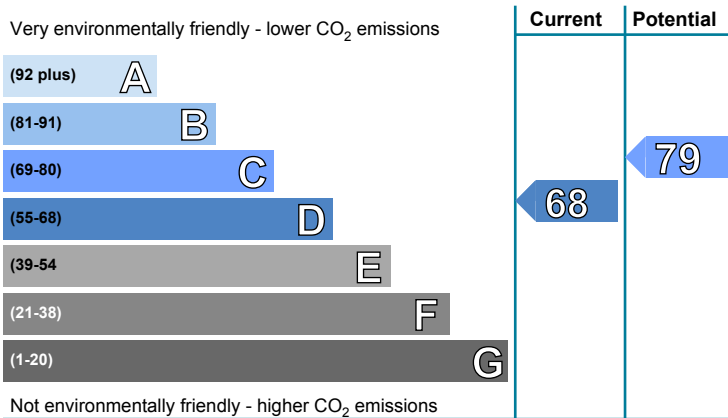
Environmental Impact (CO₂) Rating

This graph shows the effect of your home on the environment in terms of carbon dioxide (CO₂) emissions. The higher the rating, the less impact it has on the environment.
